## Operations Update

## Maintenance Update

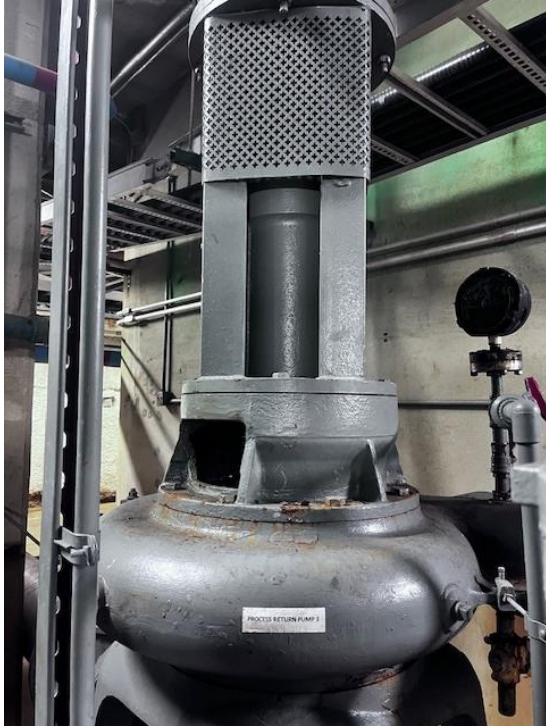
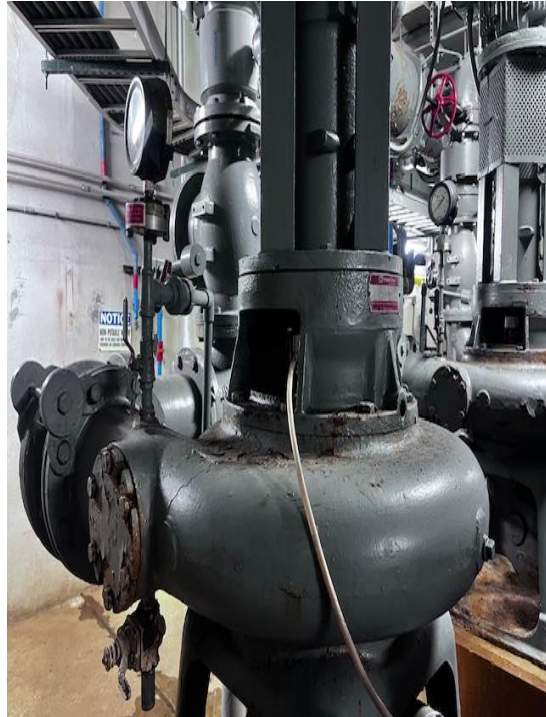
**Process Return Pump #3:** This pump was installed in 1996 and had the bearing and mechanical seal rebuilt in 2010. Currently, the impellor clearance cannot be adjusted on the unit because the mechanical seal is stuck in place and needs to be replaced. More recently the volute had a hole form that started to leak which caused the unit to be taken out of service. We got a quote for all the rebuild parts that should be needed and that came to \$33,800. We also requested a complete pump price and that came in at \$52,378. Considering the age and condition of the pump, my recommendation is to go with the complete replacement pump rather than rebuilding a 25-year old pump.

I'm looking for commission approval to go forward with the purchase of the complete pump replacement at a cost of \$52,378.
