## Operations Update

## Maintenance Update

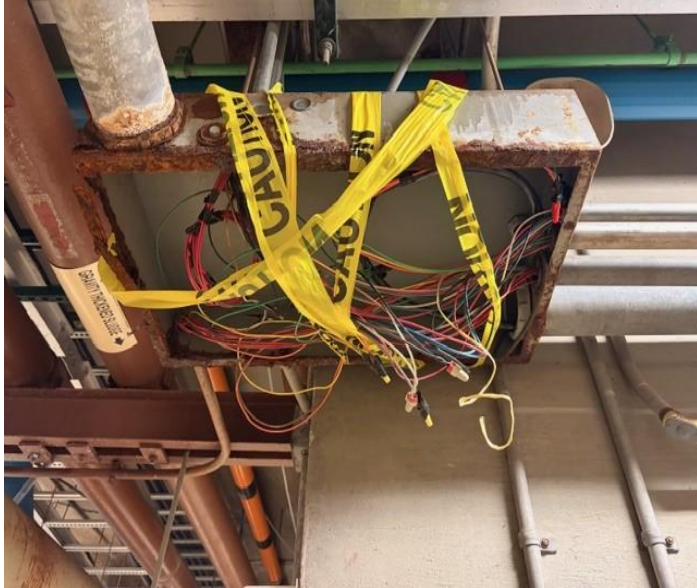
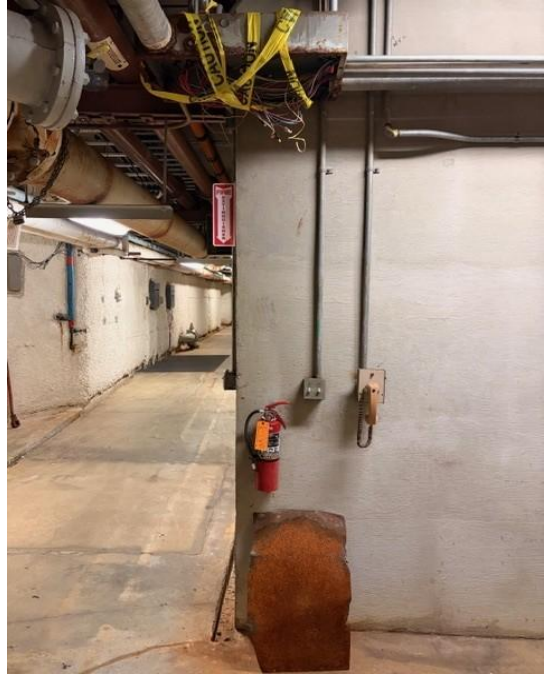
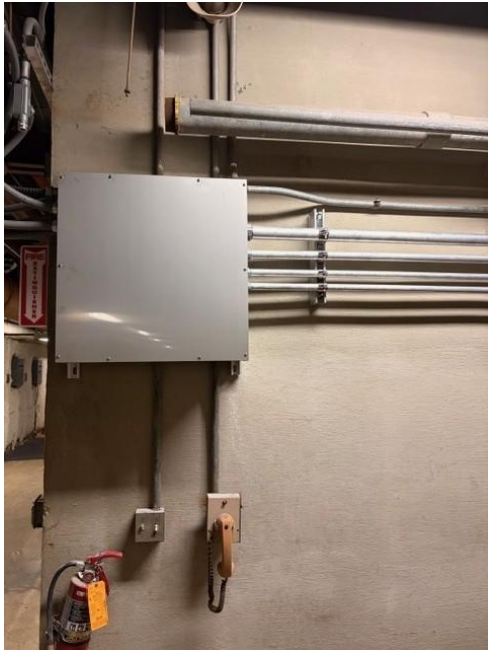
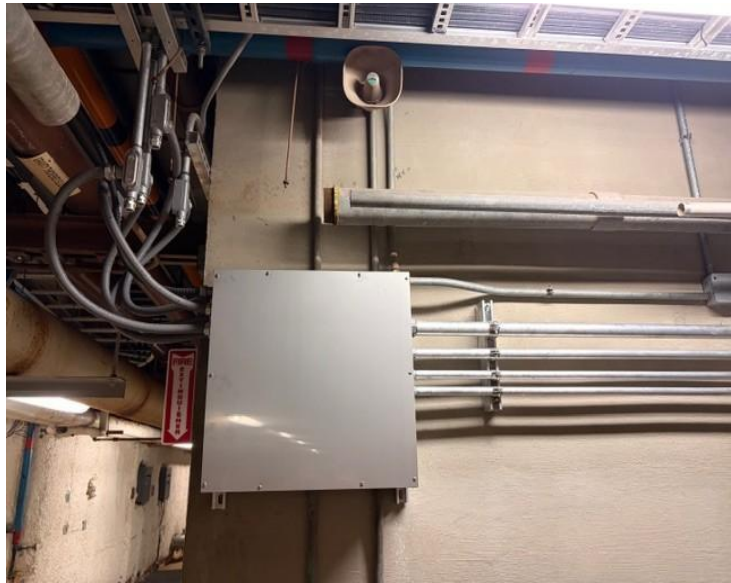
**Tunnel B Junction Box Replacement:** Sargent Electric has completed this project and the end result looks really nice compared to our old rusty junction box.
