Date:	November 11, 2019
Client:	Heart of the Valley Metropolitan Sewerage District (HOVMSD) Strategic Municipal Services Inc. (SMS)
Project Description:	Corrosion Assessment – Wastewater Interceptor System

Sample Sources:	Wastewater Interceptor System
Sample Date:	September 9, 2019
Tests by WQI:	Biofilm Indication Test (BIT) and Biofilm Activity Test (BAT)

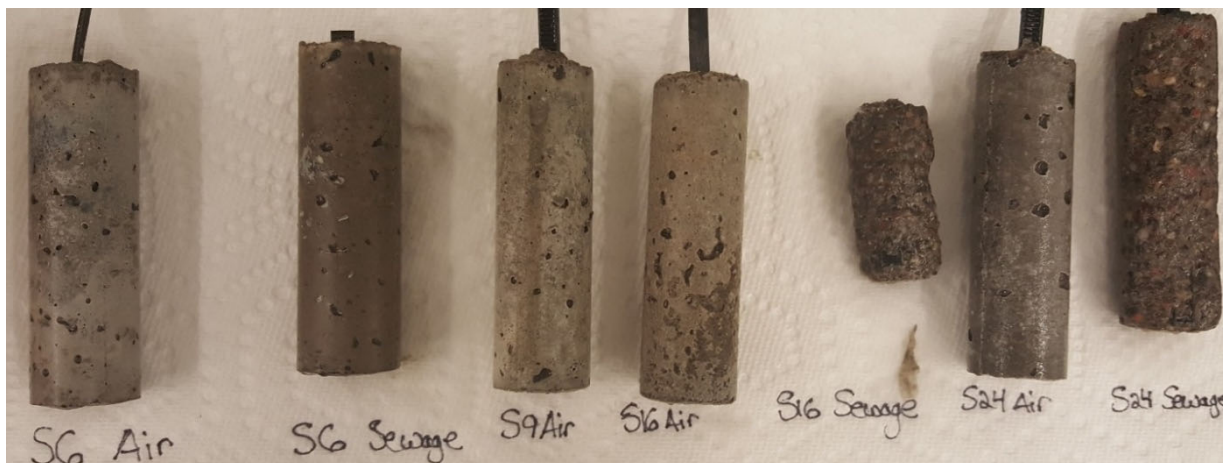
1. **Figure 1** and **Figure 2** generally shows the following:
 - a. Concrete coupons hung in air show no apparent signs of MIC, though appearances differed.

- i. Site S6 shows normal colored concrete.
 - ii. Sites S9 and S16 show slight browning of the concrete.
 - iii. Site S24 shows a slightly darker colored concrete.

- b. Concrete coupons submerged in sewage showed variable results.
 - i. Site S6 shows no sign of MIC damage
 - ii. Sites S9 and S16 show severe MIC damage – about 70% of the coupons are corroded away or missing.

- iii. Site S24 shows moderate MIC damage – 10% to 30% of the coupons are corroded away or missing.
 - c. Color patterns of the coupons hung in air show a correlation to corrosion seen on coupons submerged in sewage.

Figure 1. Appearance of harvested concrete coupons subjected to direct lyse (BIT Table 1 data). No sample was available from S9 sewage for analysis. Sample from S16 sewage was split at a crack to create two samples for analysis.

- Identify and remove point sources of ammonia or require pretreatment of these sources.
- Addition of an iron salt such as ferric sulfate at Site S24 to reduce the metal deficit seen in the water.
- Modification of drop structures to minimize/prevent off gassing of ammonia and/or sulfide.
- Periodic purging of stagnant regions with river water at low flow times to reduce off gassing caused by stagnancy.
- Filling of redundant siphons with river water after use to minimize off gassing and anaerobic activity between periods of use.

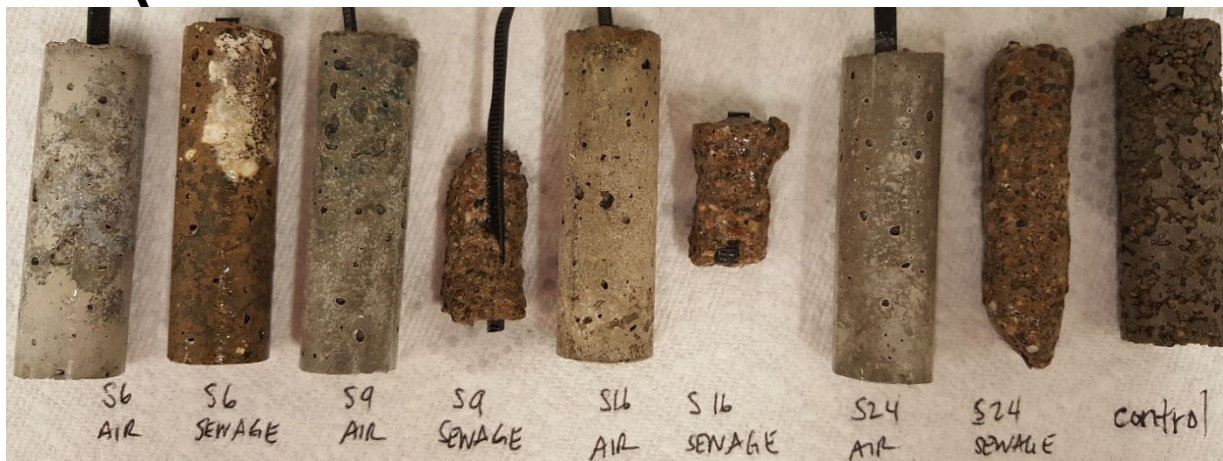
Figure 2. Appearance of harvested concrete coupons subjected to soaking in ultra-pure water for analysis of products excreted by biofilm present on the coupon surfaces (BIT Table 2 and BAT Table 1 data) . Sample from S16 sewage was split at a crack to create two samples for analysis. Sample S6 shows the presence of fats, oils and grease (FOG) on the surface of the coupon. Photo was taken three days after analysis and does not necessarily represent condition of the coupons immediately after analysis.
